CALL-OFFICE INSTALLATIONS

Maintenance Procedure

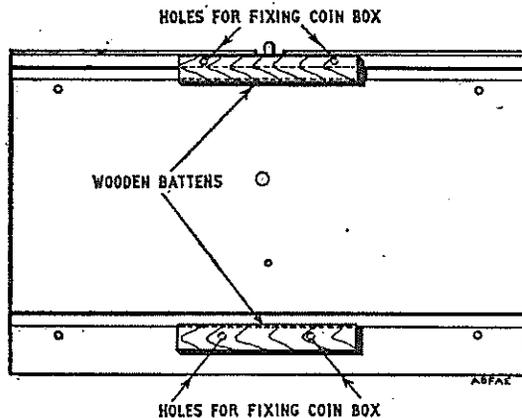
FIG. 5. REAR FACE OF WALLBOARD
D 2/60577. POSITIONS IN WHICH
BATTENS ARE TO BE FIXED

(a) Fit two wooden battens $\frac{3}{4}$ in. \times $1\frac{1}{2}$ in. \times 10 in. on the rear face of the Wallboard D 2/60577, in the position indicated in Fig. 5.
